**State of Louisiana  
Department of Natural Resources  
Coastal Engineering Division**

**2005/2006 Annual Inspection  
Report**

**LAKE PORTAGE LAND  
BRIDGE PROJECT  
(TV-17)**

October 20, 2005  
Vermilion Parish

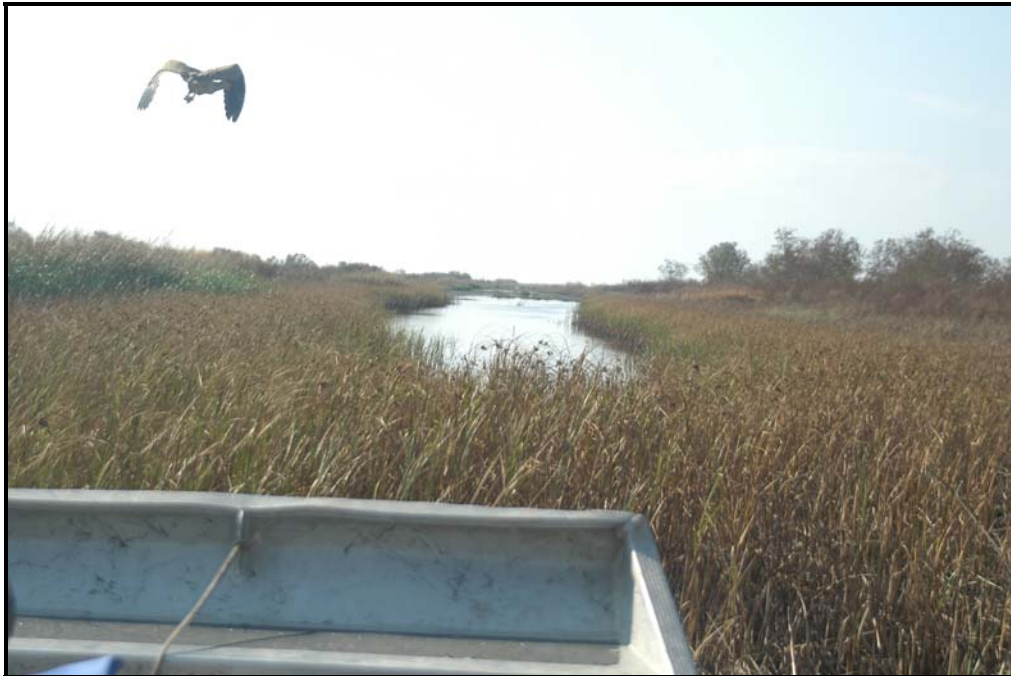
Area 1 is in good condition and vegetation has continued to expand from the containment banks moving towards the center of the channel. Recent aerial photographs taken by LDWF show increased vegetation growth which should continue with warmer temperatures into the future. In some areas the entire channel width was vegetated. The center part of the filled in channel was wet, passable only by airboat, and is still draining storm surge water from Hurricane Rita. Salinity was measured at 14 ppt in the channel area. As a result of the

inspection of Area 1, LDNR and NRCS agree that no corrective actions will be required this year. (Photos: Appendix B, Photo 1).

Photo 1, Area 1, Post Hurricane Rita. Note vegetation has completely filled in the plug area in some places.

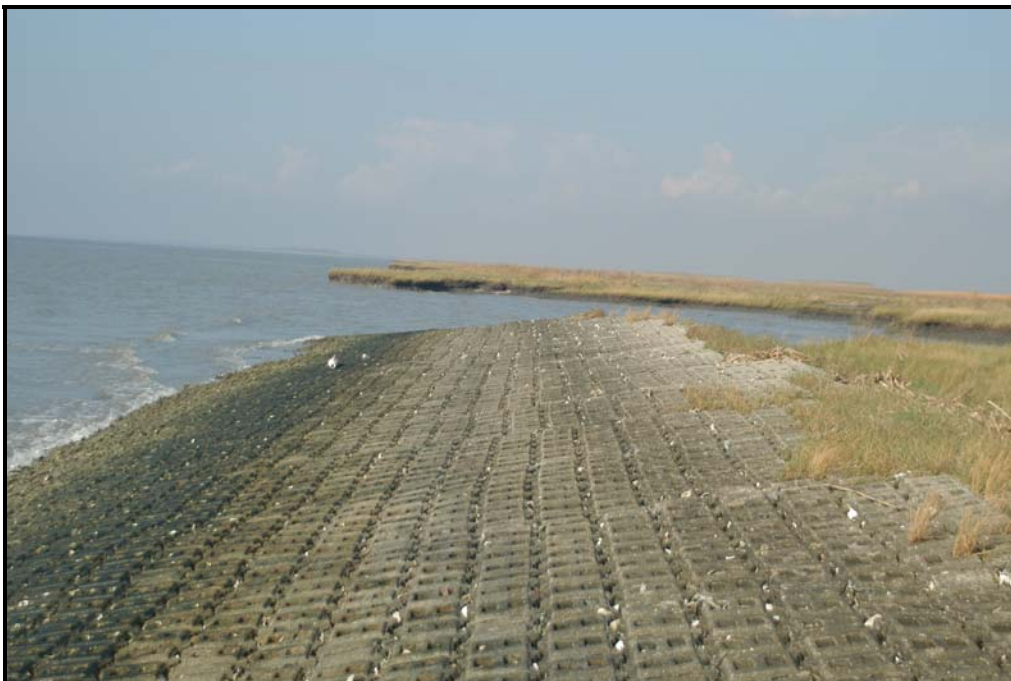
Area 2 is also in good condition and is fully vegetated, such that this reach was preexisting with additional dredge material added through this project to fill in any trevasses. Some erosion along the ends of the concrete mats along the Gulf shoreline has occurred due to Hurricane Rita. Salinity was measured at 16.5 ppt in the Gulf waters. LDNR and NRCS agree that no maintenance will be required at this time; however this area needs to be monitored closely on future annual inspections. (Photos: Appendix B, Photos 2, 3, 4, & 5).

Photo 2, Area 2, Post Hurricane Rita, West side of concrete mats.

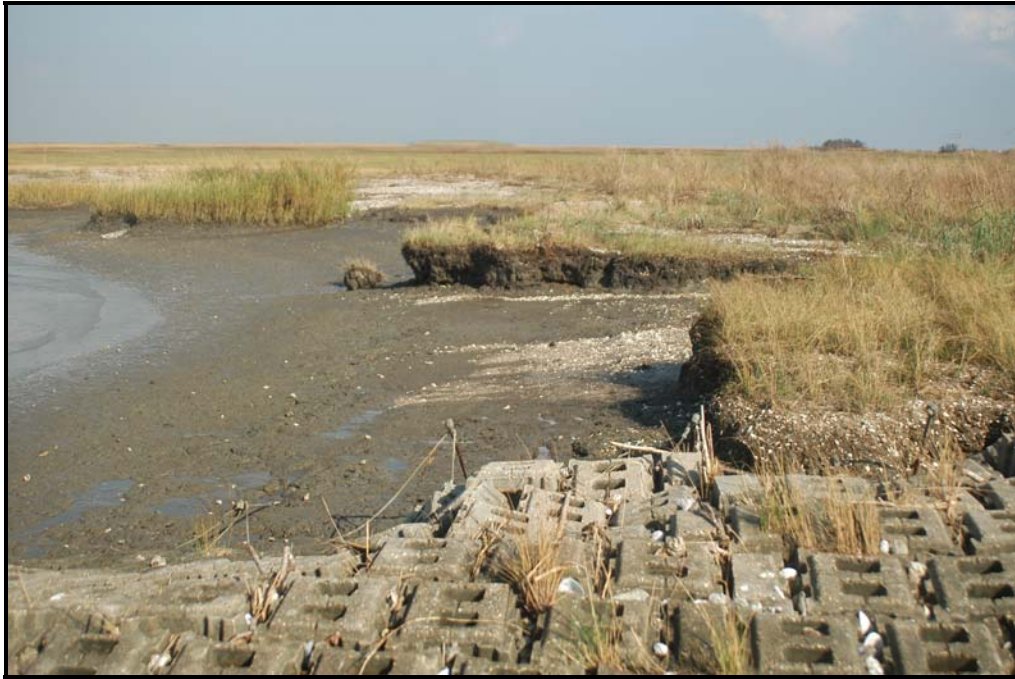
Photo 3, Area 2, Post Hurricane Rita, Close up view of erosion on west side of concrete mats.

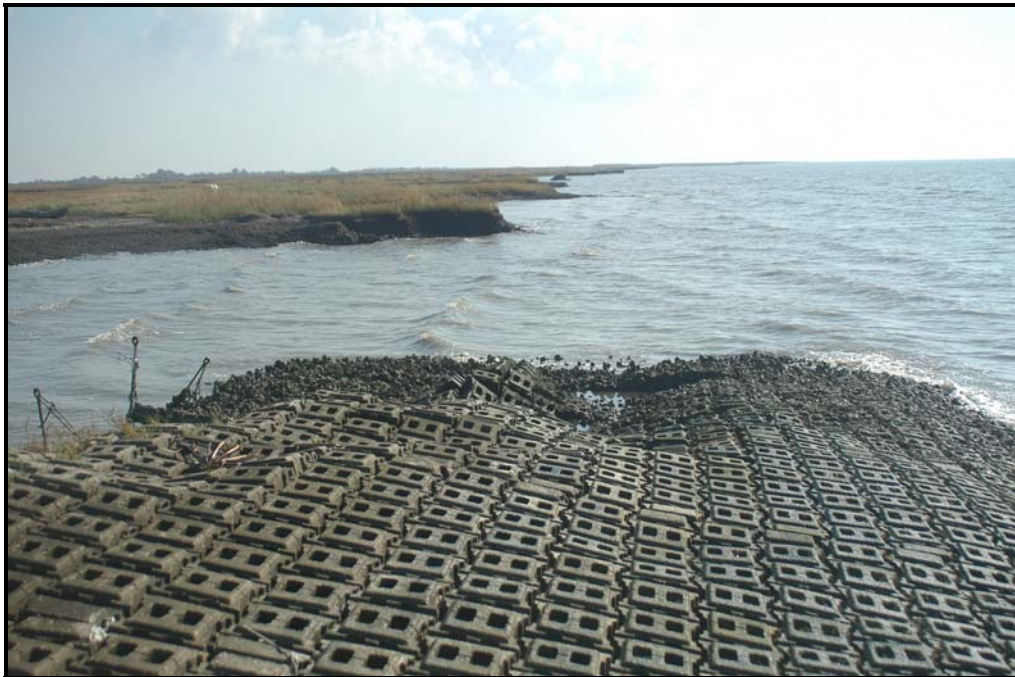
Photo 4, Area 2, Post Hurricane Rita, East side of concrete mats.

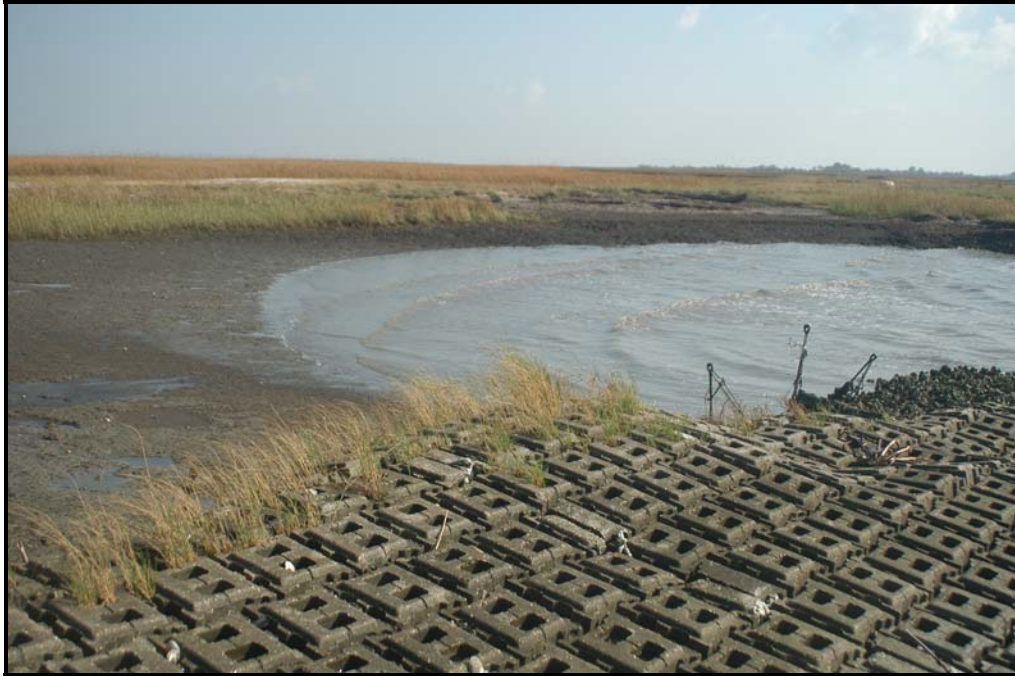
Photo 5, Area 2, Post Hurricane Rita, Close up view of erosion on east side of concrete mats.

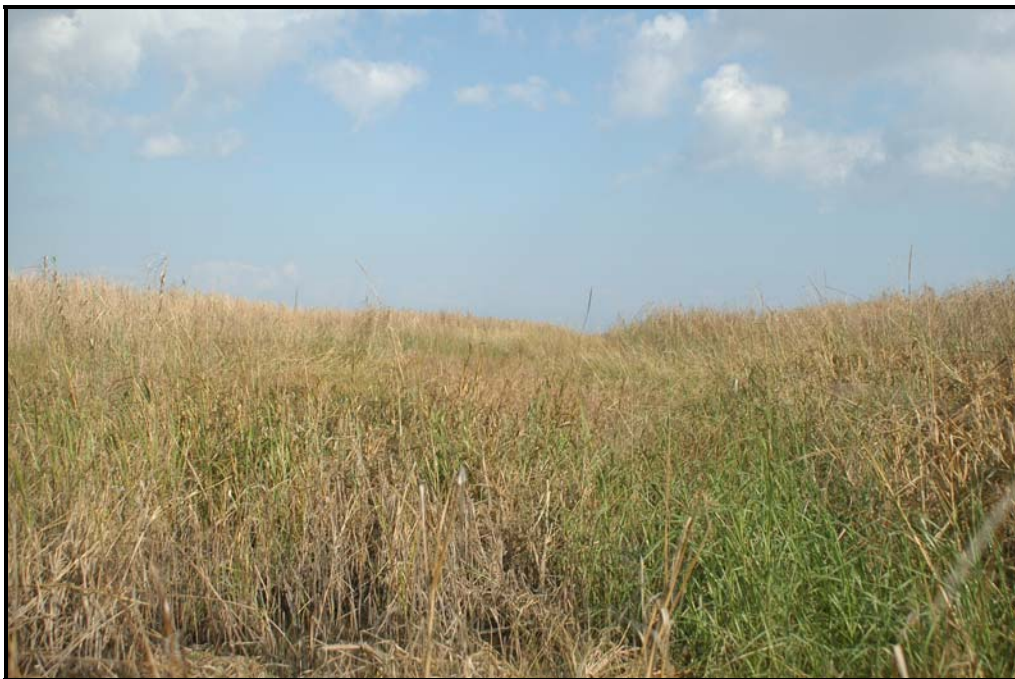
Area 3 also is in good condition. The northern part of this reach is fully vegetated, mainly due to the fact that this reach was constructed first, and has been in place since May, 2003. There is some minor erosion occurring on each side of the northern timber bulkhead which will need to be monitored on future annual inspections. LDNR and NRCS agree that this area is in good condition and no maintenance will be required at this time. (Photos: Appendix B, Photos 6, 7, & 8).

Photo 6, Area 3, Post Hurricane Rita, Still fully vegetated.

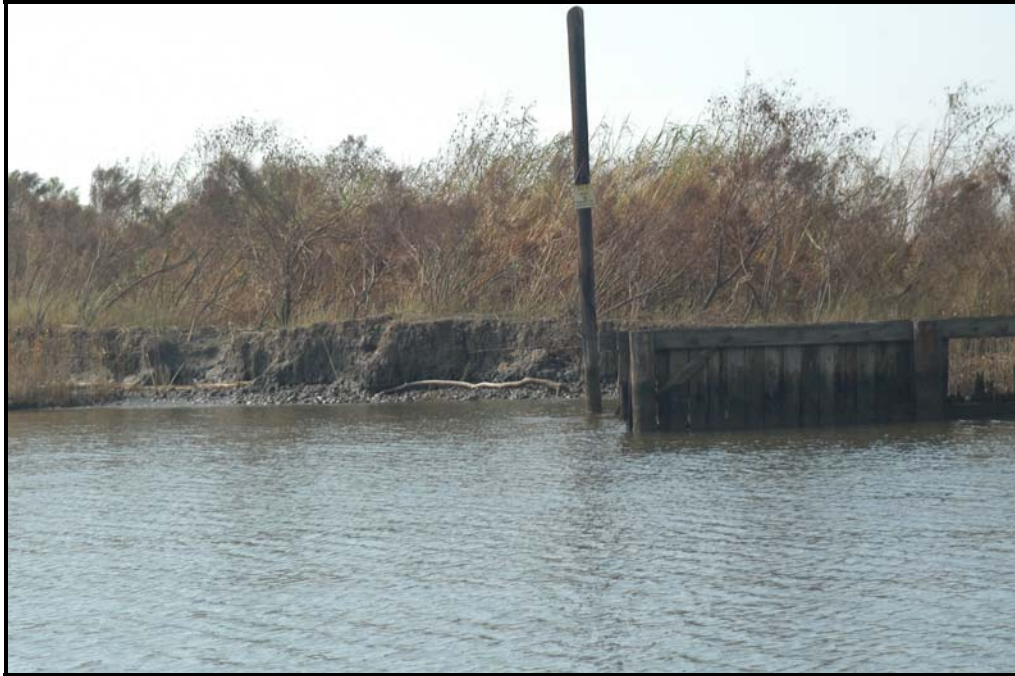
Photo 7, Area 3, Post Hurricane Rita, Showing erosion along east side of timber bulkhead.

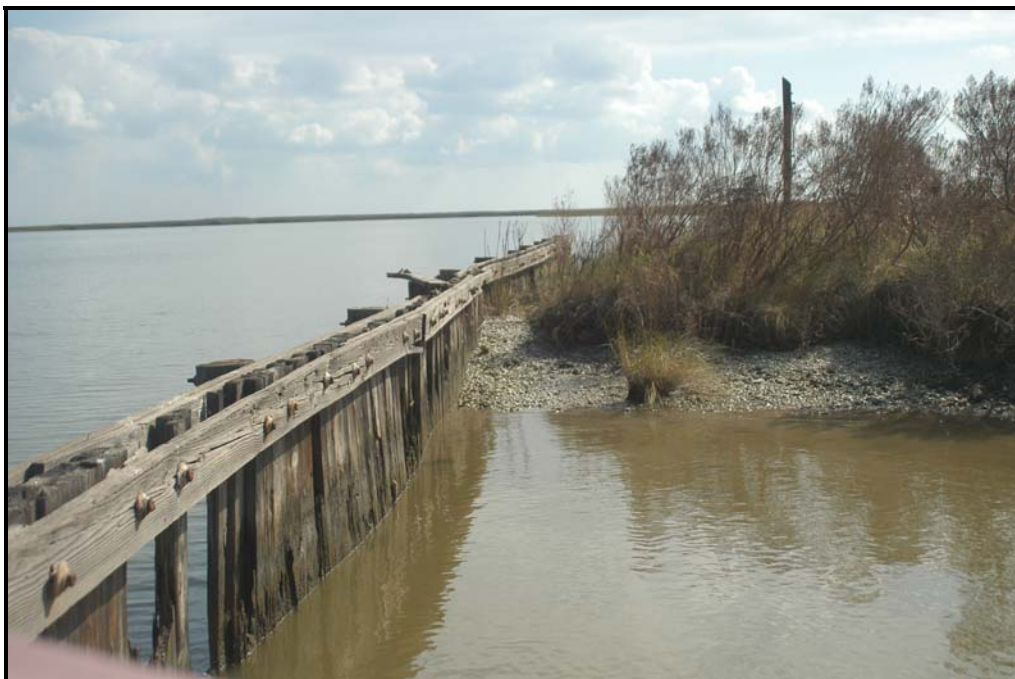
Photo 8, Area 3, Post Hurricane Rita, Showing erosion along west side of timber bulkhead.
